Chinatown Historic Resources Survey
City of Fresno, Planning and Development Department
4 April 2006

Appendix A. Department of Parks and Recreation 523 Forms for Individual Properties

Page 1 of 4 Resource Name or #: (Assigned by recorder) 921-927 China Alley

P1. Other Identifier: Bing Kong Association Building
 P2. Location: Not for Publication Unrestricted a. County Fresno
 and (P2b and P2c or P2d. Attach a Location Map as necessary.)
 b. USGS 7.5' Quad Fresno South Date 1978 T _____ ; R _____ ; 1/4 of _____ 1/4 of Sec _____ ; B.M. _____
 c. Address 921 China Alley City Fresno Zip 93706
 d. UTM: (Give more than one for large and/or linear resources) Zone 11 ; 250471 mE/ 4068583 mN
 e. Other Locational Data: (e.g., parcel #, directions to resource, elevation, etc., as appropriate)

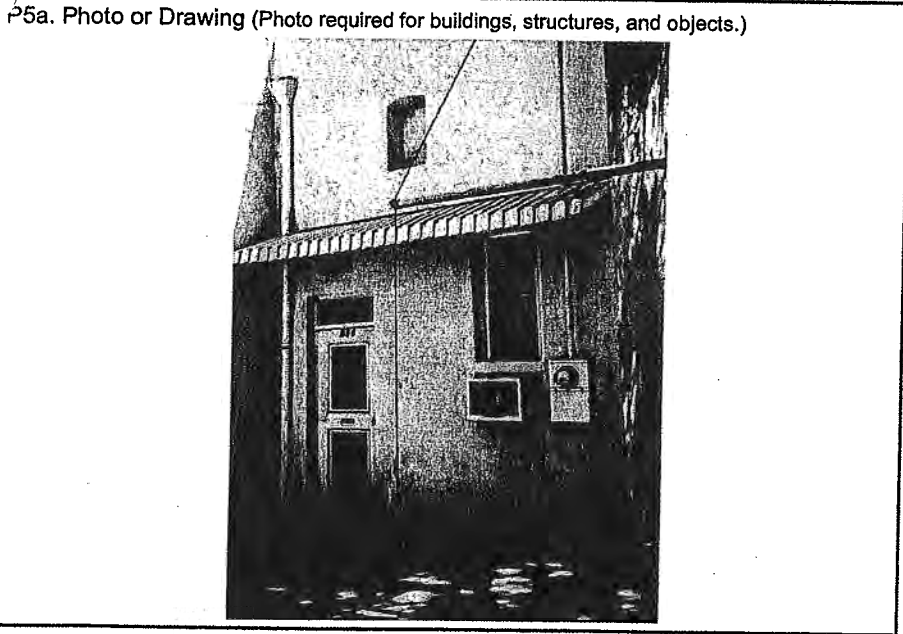
P3a. Description: (Describe resource and its major elements. Include design, materials, condition, alterations, size, setting, and boundaries)
This single-story commercial building has a rectangular footprint. This is a brick structure laid in a running stretcher pattern, with applied stucco on two (southwest and southeast) facades. The roof is flat with no ornamentation. The first floor includes a glazed door with transom; a four-lite window occupies the east end of the front façade. An aluminum awning projects above the main doorway. A small semicircular arched opening is centrally located in the upper portion of the southwest façade.

P5b. Description of Photo:
(View, date, accession #)
View looking northwest, May 2005

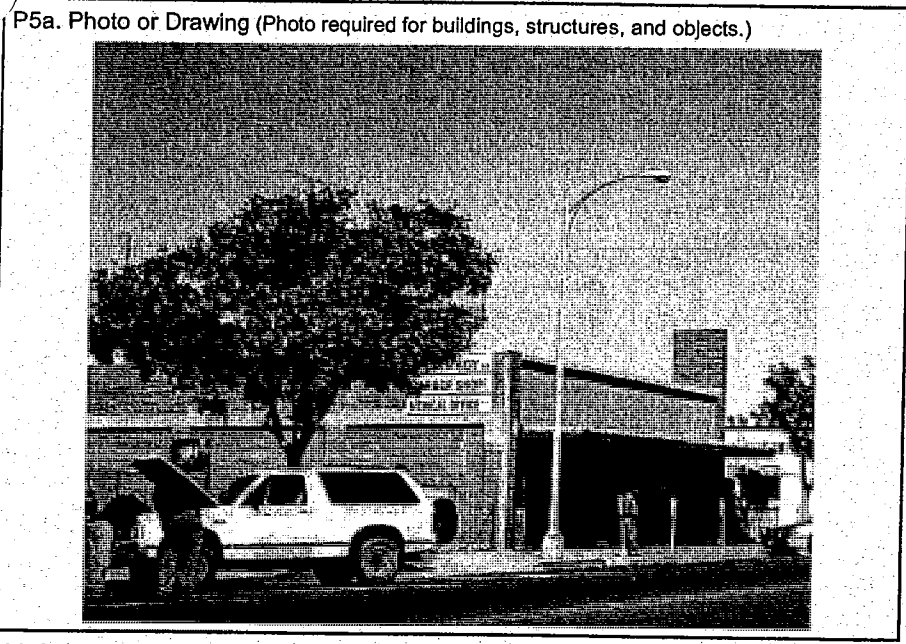
P3a. Description: (Describe resource and its major elements. Include design, materials, condition, alterations, size, setting, and boundaries)
 This one-story commercial structure has a rectangular footprint and flat roof. The body of the structure is common (American bond) brick. Stacked brick runs below the sill line on the front (southwest) façade. A large overhang extends across the length of the building, above the window line. Large glass commercial windows as well a pair of glazed doors complete this façade. A visual point of interest is the narrow brick wall, two stories in height and constructed in stacked brick applied to the east side of the southwest facade.

P5b. Description of Photo:
 (View, date, accession #)
View looking west, May 2005

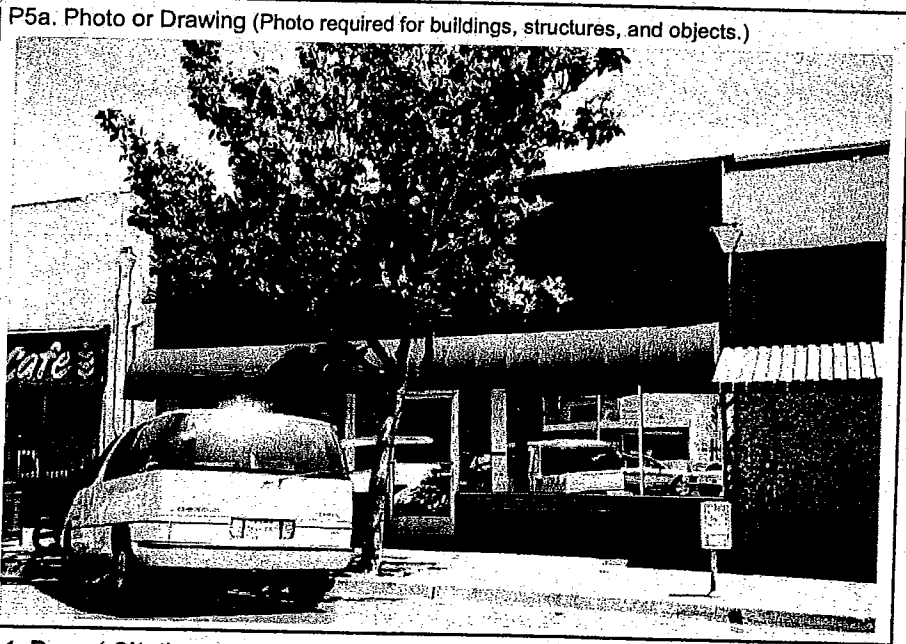
P3a. Description: (Describe resource and its major elements. Include design, materials, condition, alterations, size, setting, and boundaries)
This single-story commercial structure has a rectangular footprint with parapet roof. A centrally-placed glazed metal door interrupts an enframed window wall. Bricks in a running stretcher pattern run below the sill line, adding texture and ornament to the façade. An awning extends above the enframed window wall creating spatial division. A corrugated metal panel fills the façade above the canopy, extending to the roofline.

P5b. Description of Photo:
(View, date, accession #)
View looking north, May 2005

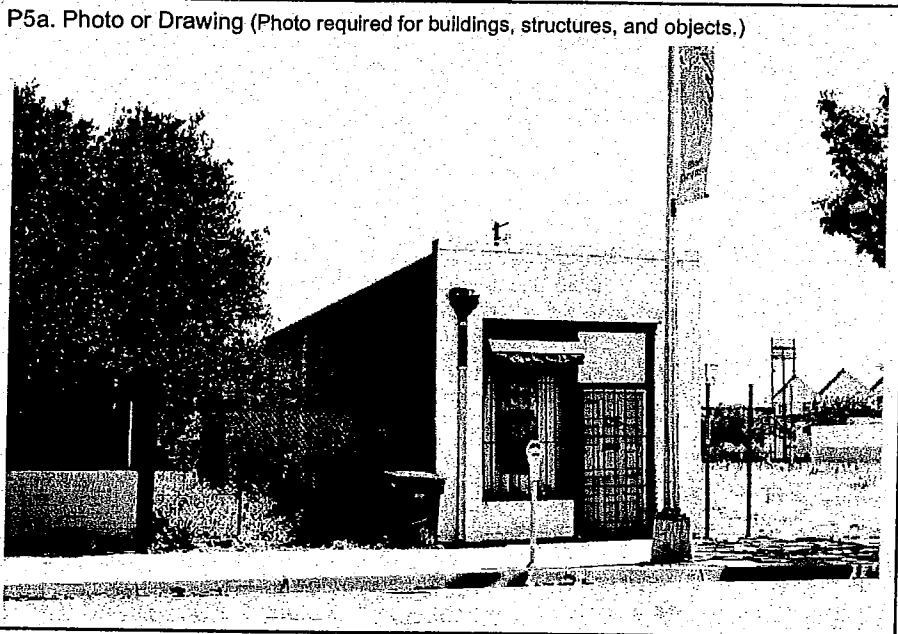
P5a. Photo or Drawing (Photo required for buildings, structures, and objects.)
P5b. Description of Photo:
(View, date, accession #)
View looking east, May 2005

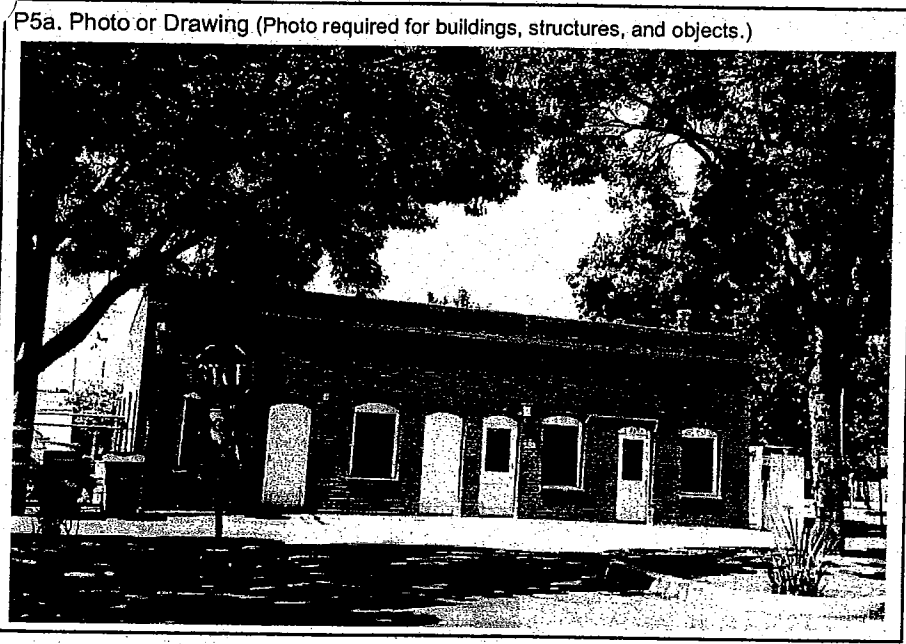
P5b. Description of Photo:
 (View, date, accession #)
View looking west, May 2005
